# Confidential Inspection Report

9301 T Maia Bradley Ln

Taisburg, MD 20876

Prepared for: Mr Happy HomeOwner

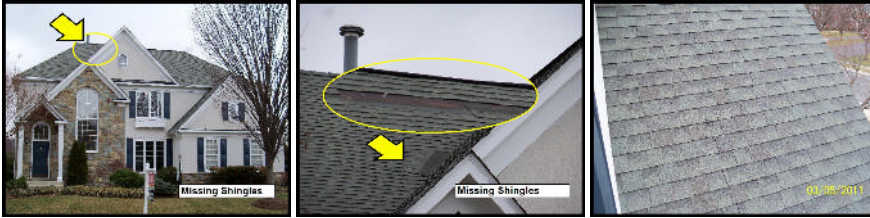
The Front of the Roof. At the front left side of the roof the following issue(s) was/were found;

Damage Noted. The following damage was noted on the roof. Further evaluation by a qualified Roofing Contractor is recommended

Missing Shingles. One or more layers of roofing shingles appear to be missing from the roof. Missing shingles weaken the protection afforded the sub-roof from the elements and may result in water damage to the sheathing including but not limited to wood decay and mold.

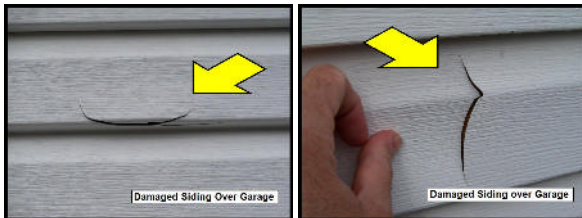
**Minor Damage.** Minor damage to the vinyl siding was found above the garage door in several places. This damage is minor and can be easily and inexpensively repaired. Recommend consulting with a qualified siding contractor for further evaluation and repairs as needed. The damage was likely caused by basketballs as a basket was adjacent.

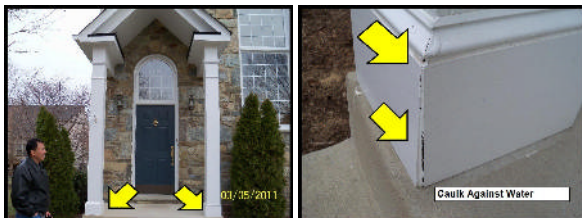
**Caulking & Paint.** Evidence of caulking & paint deterioration was noted at the foot of the columns located at front entry stoop.

Up-dating the caulking and paint on the affected elements is recommended to prevent water &/or moisture infiltration which may lead to more significant issues in the future. Contacting a qualified contractor for repairs is recommended.

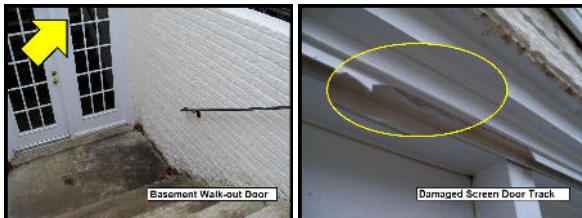
Basement Walk-out. Screen Door Track. The track for the basement door screen is damaged. The plastic track has been broken in several places and likely would not hold a screen in its present condition. If the installation of a screen door is desired this track will require replacement.

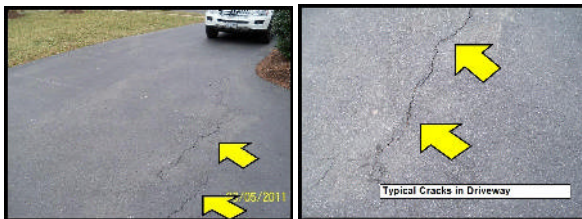
Minor Cracks. Minor cracks were noticed on the driveway's surface. These cracks are not of structural concern. The cracks should be sealed with a silicone or other polymer-based sealant to prevent water penetration which may lead to further future damage.

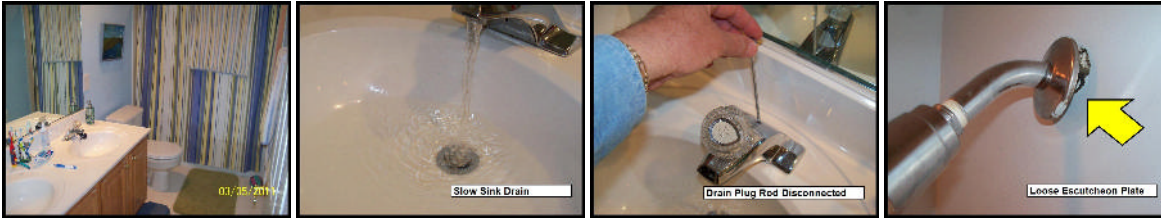
escutcheon plate should be flush to the wall and sealed to prevent water &/or moisture from penetrating behind the tile &/or entering the sub-wall space where it may cause decay, mold or other issues. Recommend repairing.

Faulty Ventilation Fan. The ceiling mounted ventilation fan was not operating at the time of this inspection. Ventilation fans are critical in venting hot, moisture-laden air during showers to prevent mildew and mold issues. Recommend repairing or replacing.

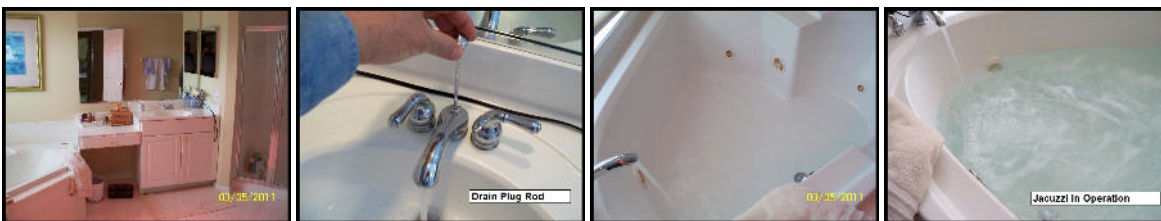
Faulty Sink Plug. The sink drain stopper is not operating properly. The drain plug rods appear to have been disconnected in the cabinet underneath the sink (possibly due to the presence of small children to prevent flooding). Recommend re-connecting.

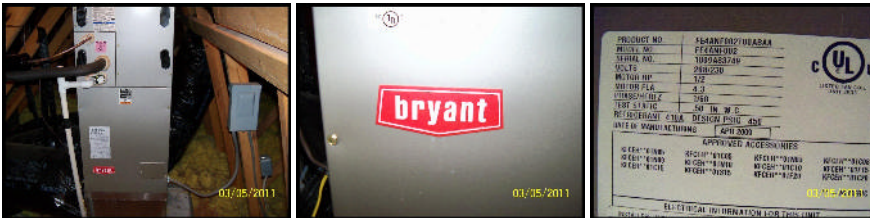
Professional Evaluation Required. Given the age & condition of this furnace as well as a lack of maintenance records and the limited visual inspection of the Heat Exchangers, a thorough professional evaluation by a qualified HVAC technician is strongly recommended.

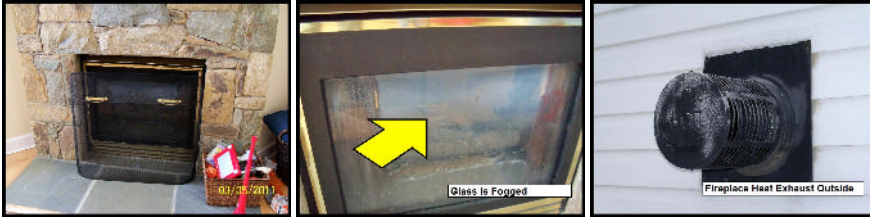
The following issue was noted;  
Fogged Glass on Fireplace. The glass on the front of the fireplace is fogged from age & use. Recommend cleaning ir replacing for esthetic reasons.
