# Confidential Inspection Report

9301 T Maia Bradley Ln

Taisburg, MD 20876

Prepared for: Mr Happy HomeOwner

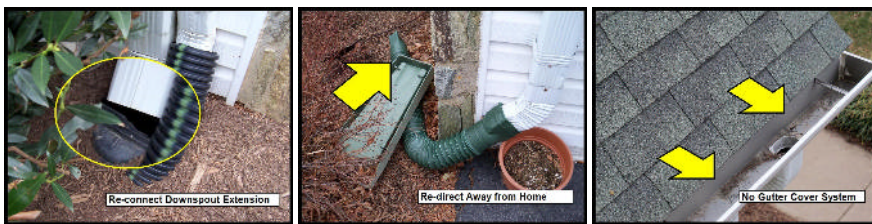
Good Surface Drainage. A visual inspection of the terrain surrounding the structure indicates there is positive grade draining away from the house.

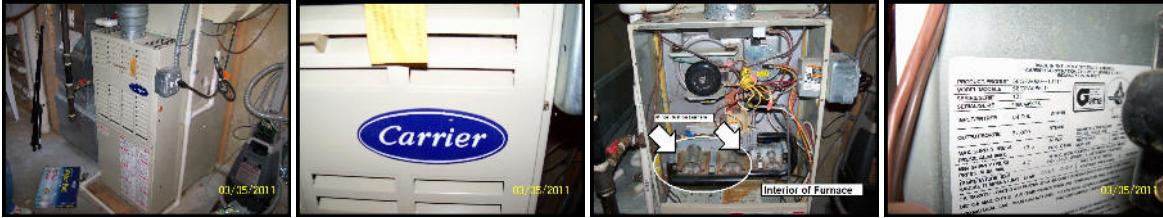
A faulty gas furnace, especially one with compromised heat exchangers is a serious health hazard due to the potential of Carbon Monoxide entering the air distribution system and negatively affecting residents' health up to and including the possibility of death.

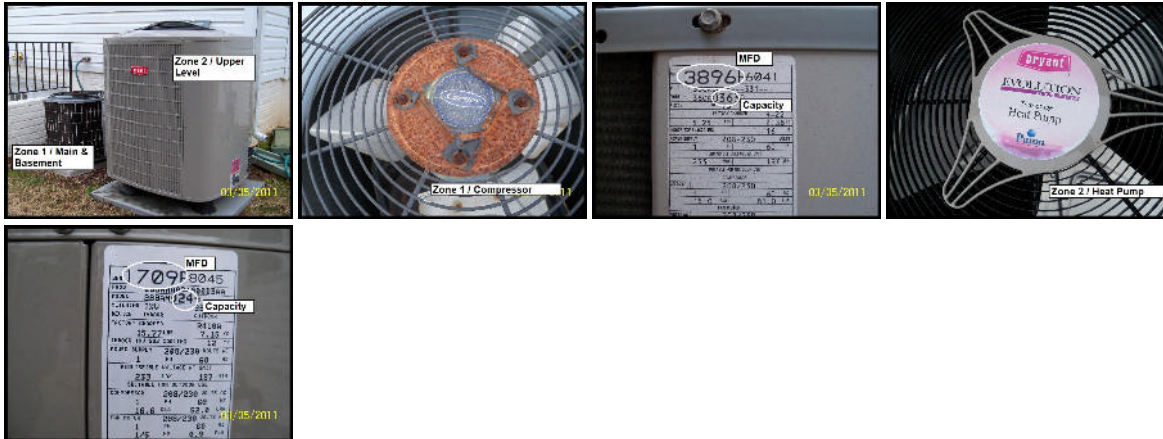
Manufacturer's Life Expectancy (MLE). This unit is 2 years old. The Manufacturer's Life Expectancy (MLE) for this type of appliance is 12 - 15 years. Periodically monitoring the unit for rust and leakage is recommended. Yearly maintenance is critical for both longevity and safety reasons. With proper maintenance these units will typically outlast their MLE by several years.

Manufacturer's Warranty. Given the age of this appliance it should still be under the original Manufacturer's Warranty. Recommend requesting all pertinent documentation, manuals and receipts for this appliance from the sellers.

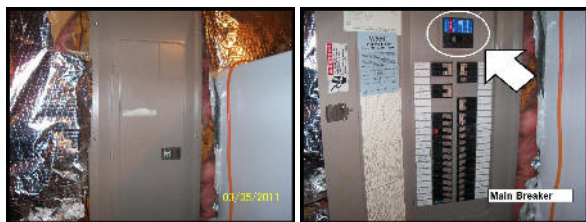
The electrical panel is functional.
